Manhole Inspection Summary

Manhole # S35C__050MH

Insp Date: **8/6/08 9:46 AM**

Location Address: **corner 330 bath st**

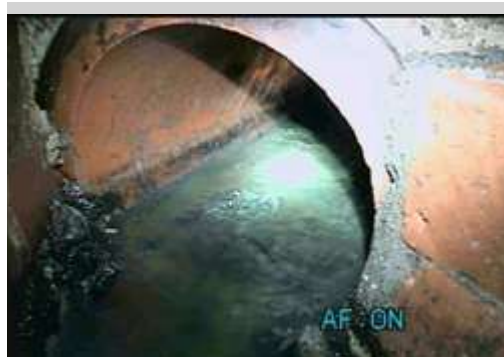
extra pipe @ 7

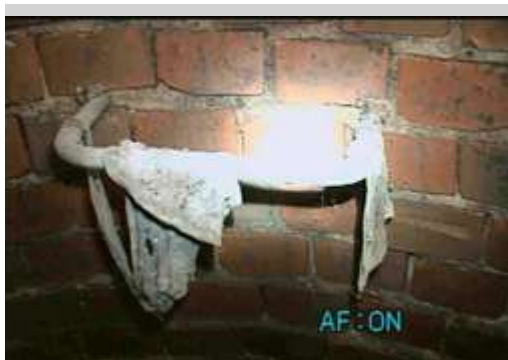
Defect 4

Surcharge ☒ **Evidence Of Surcharge** Depth: **6.** (ft.) ☐ Active Surcharge Present

surcharge evd

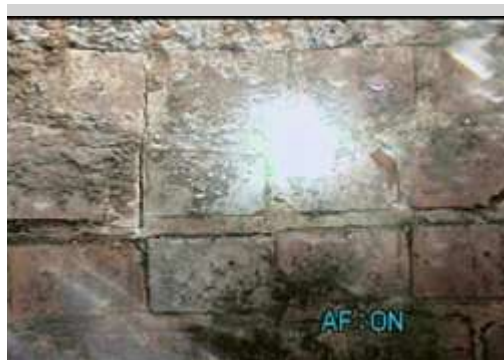
Defect 4

Condition: ☐ Sound ☒ **Cracked** ☐ Root Intrusion ☐ Loose Brick ☐ Deteriorated

cracked corbal

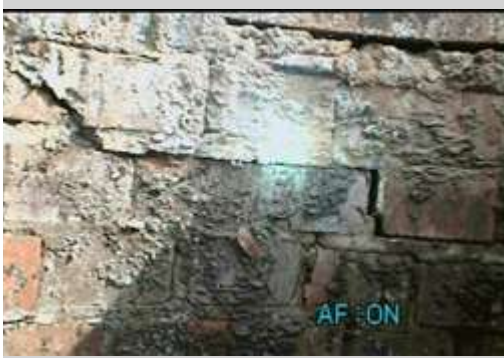
Defect 3

Condition: ☐ Sound ☒ **Cracked** ☐ Root Intrusion ☒ **Loose Brick** ☐ Deteriorated

chimney loose bricks, cracked, frame adj

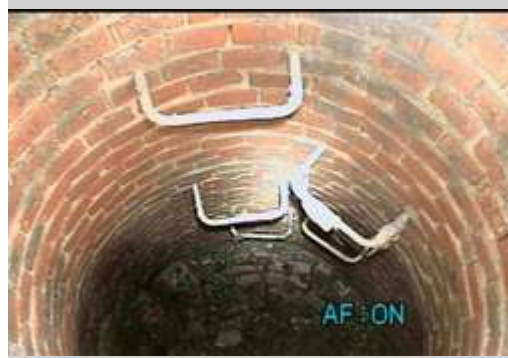
Defect 2

Steps Count: **5** Missing: **0** ☒ **Corroded**

steps

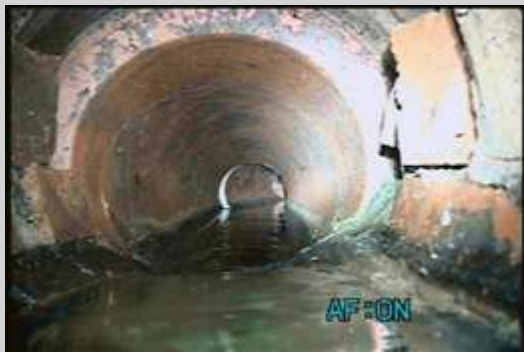
12 O'Clock Outflow

10 in. Circular Gravity Sewer
Pipe Out @ 12 O'Clock

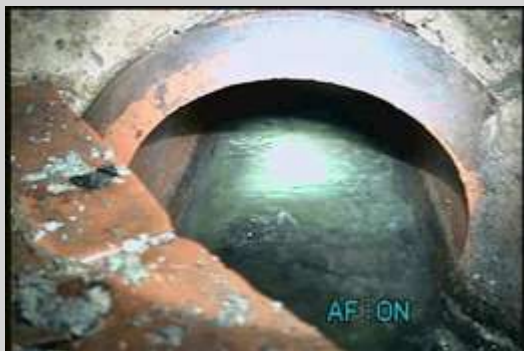
7 O'Clock Inflow

channel at angle best shot
